Project Note

Project: Lake L9322 Monitoring and Analysis	Project No: 115159
To: Sally A. Rothwell, CPAI	Project Note No: 115159-MBJ-PN-002
From: Jeff Baker, P.E.	Date: July 27, 2009
Subject: Spring Breakup 2009 Lake L9322 Monitoring and Analysis

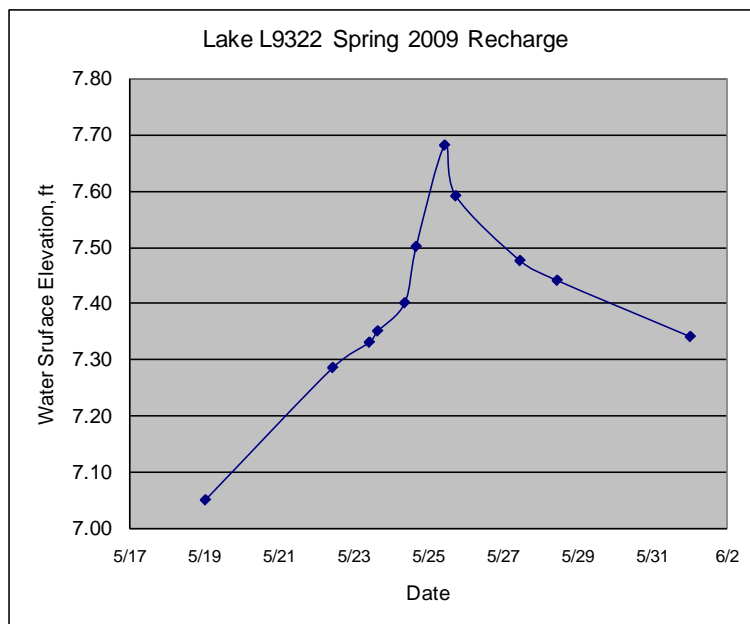
Table 2 provides a summary of field observations related to the water surface elevations observed during the spring breakup period, as well as field observations. Graph 1 illustrates the observed water surface elevations during spring breakup.

Graph 1: Lake L9322 Spring 2009 Water Surface Elevations

An initial WSE of 6.84 feet was surveyed by Baker in February 2009. At that time, local snow depth on lake ice ranged from no snow cover to approximately one foot of snow at the sampling locations. On May 19, a pre-breakup WSE was measured at 7.05 feet. During spring breakup monitoring, water levels rose to a peak measured water surface elevation of 7.68 feet on May 25, and then began to drop as lake recharge ended. Lake water surface returned to an estimated bankfull condition with a water surface elevation of approximately 7.3 ft BPMSL, as measured on June 1, 2009. Lake ice was intact throughout the monitoring event with recharge water surrounding the entire lake periphery, but concentrated on the eastern side.

Lake L9322 was fully recharged via spring breakup floodwaters. This determination is based on visual observations and the rapid rise and fall in water surface elevation observed during breakup, as illustrated in Graph 1. Recharge of the lake occurred over a period of approximately 72 hours beginning on May 22. Floodwaters from the Nigliq Channel recharged Lake L9322 above the bankfull elevation. An estimated peak water surface elevation of 7.68 feet (BPMSL) was measured on May 25. Water continued to drain from L9322 as of June 1 to an elevation of 7.34 feet (BPMSL).

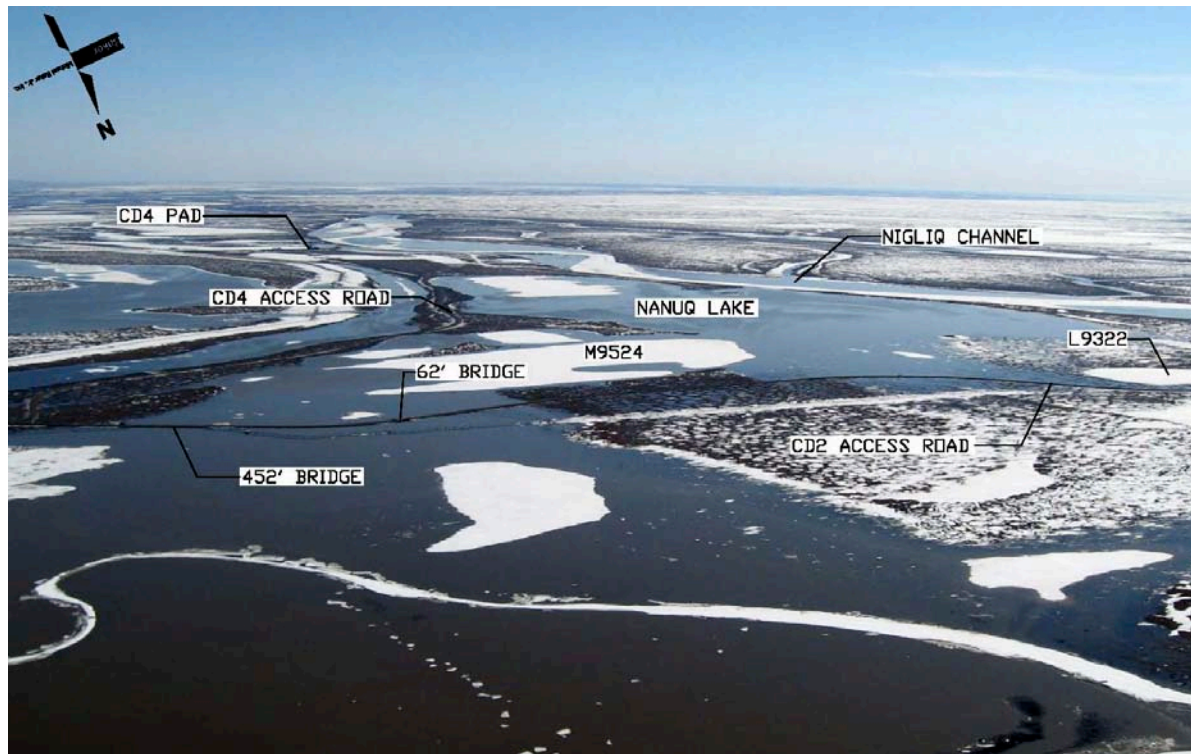
Recharge waters from the Nigliq Channel via Nanuq Lake overbank flooding reached Lake L9322 on May 24. Prior to overbank flooding, local melt and recent snows increased water surface elevations nearly 0.3 feet. Figure 2 illustrates overbank recharge flow in the vicinity of Lake L9322, concentrated on the east side of Lake L9322. Figure 3 (May 28) and Figure 4 (May 31) also show the extent of floodwater recharge defined by saturated polygons and peripheral lake water as floodwater receded and local water surface elevations dropped.

Figure 2: View looking southwest taken May 24, 2009.

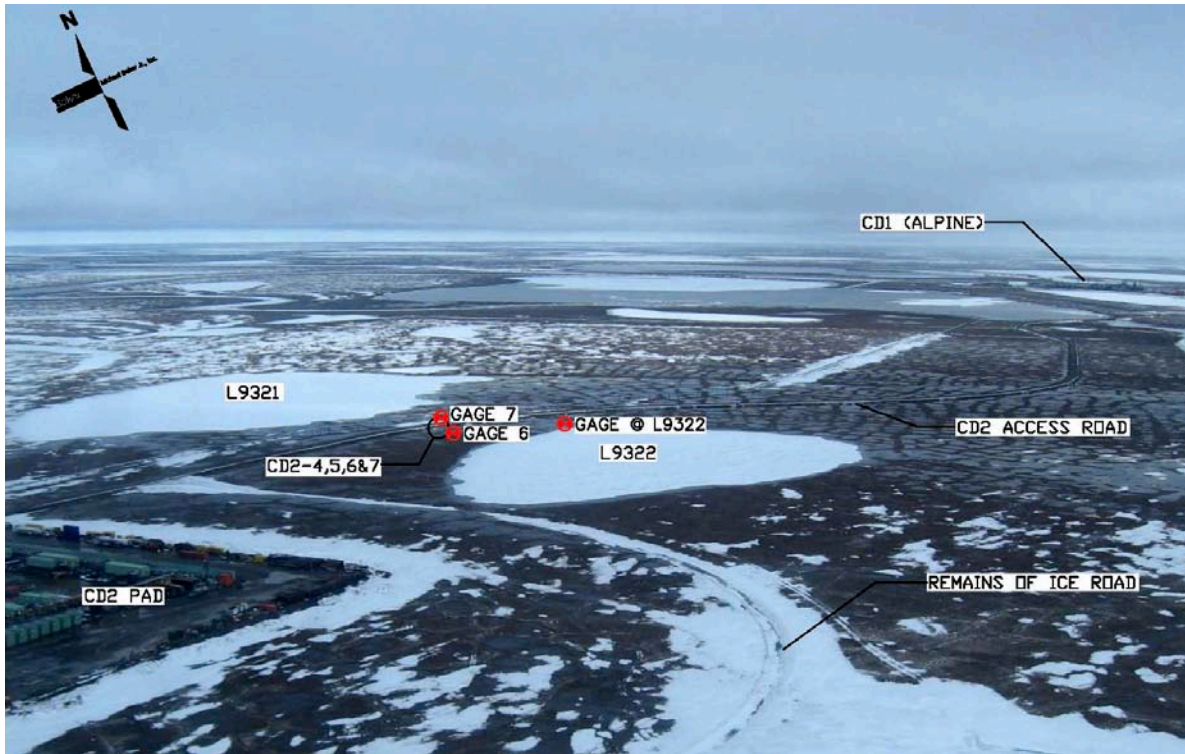
Figure 3: View looking northeast taken May 28, 2009.
